City of Vista

Health Assessment of Coast Live Oak

At Pala Vista Park

OCTOBER 9, 2023

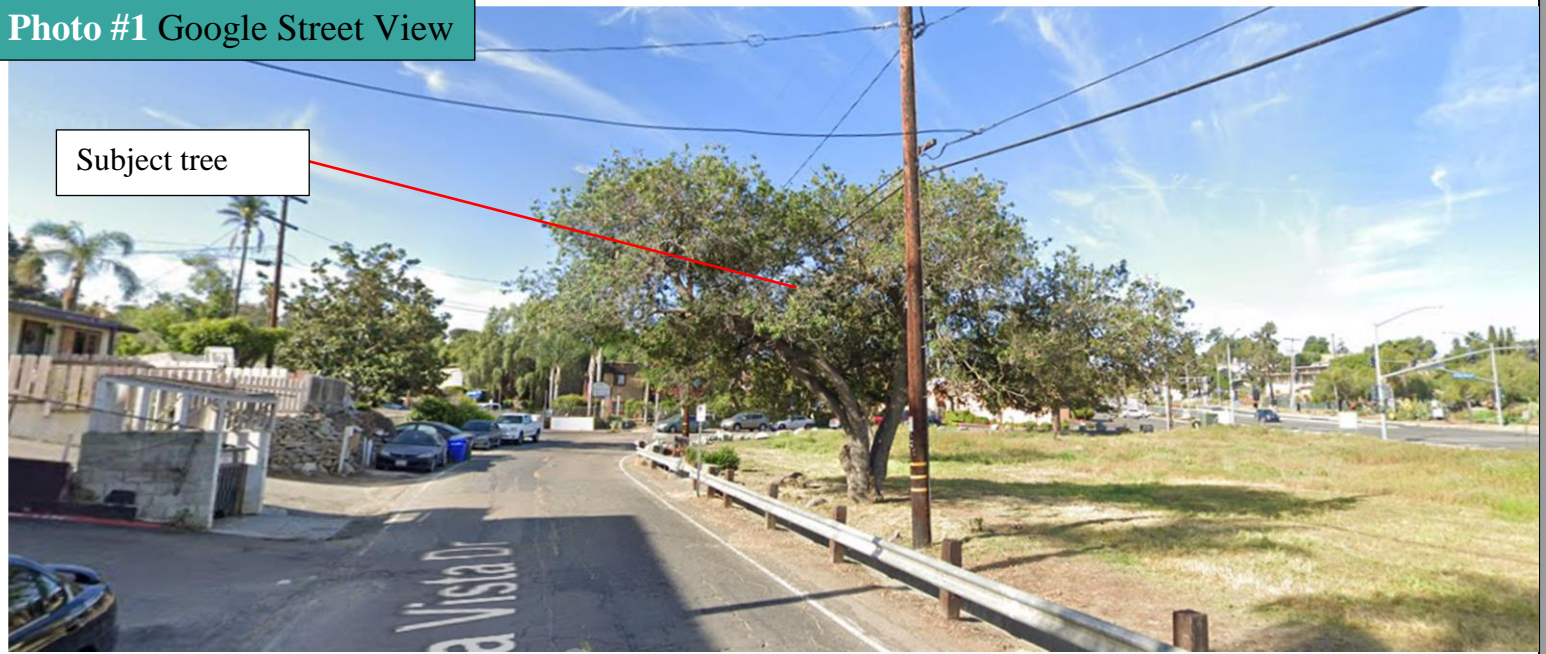
Photo #1 Google Street View

Shown above is a Google Street View image of the tree from April 2019 before construction of the park. At this time, the tree appeared to be in fair health.

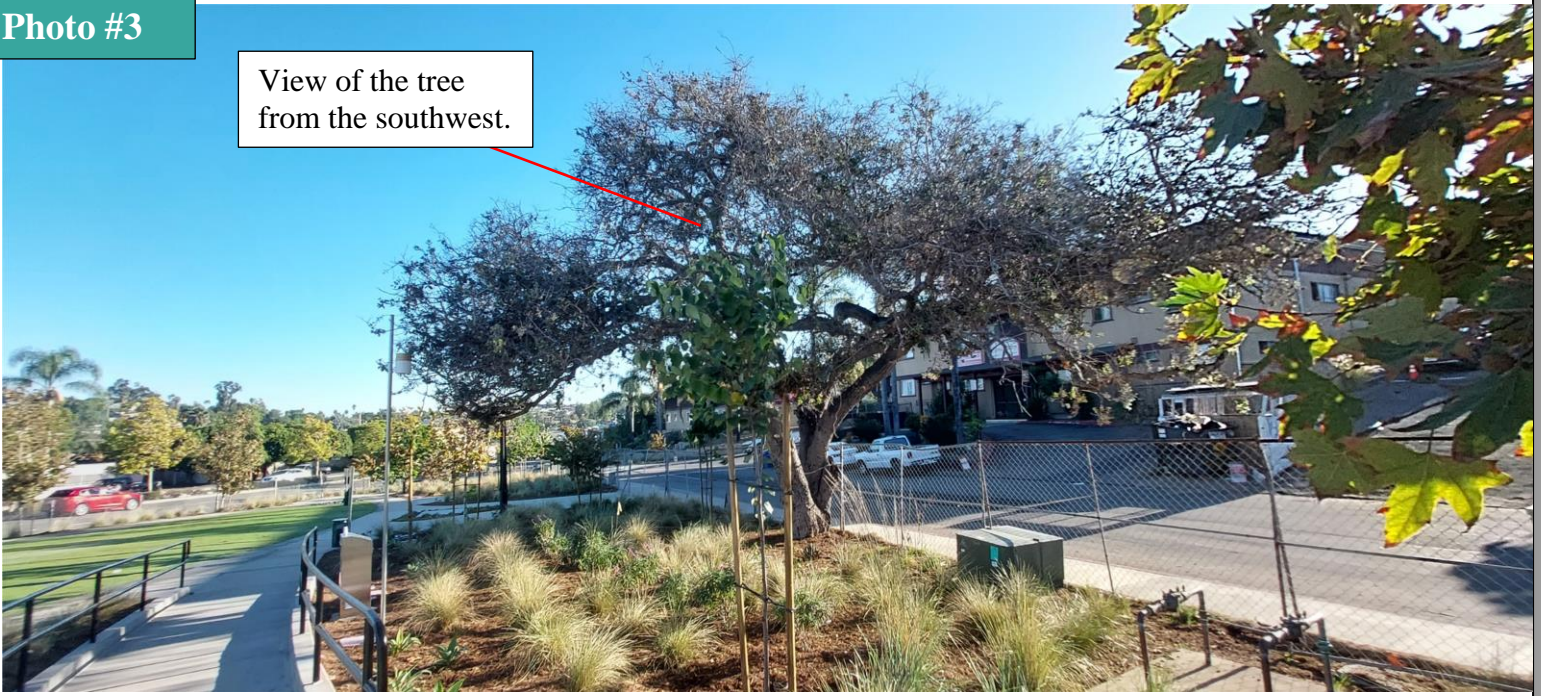
Photo #3

View of the tree from the southwest.

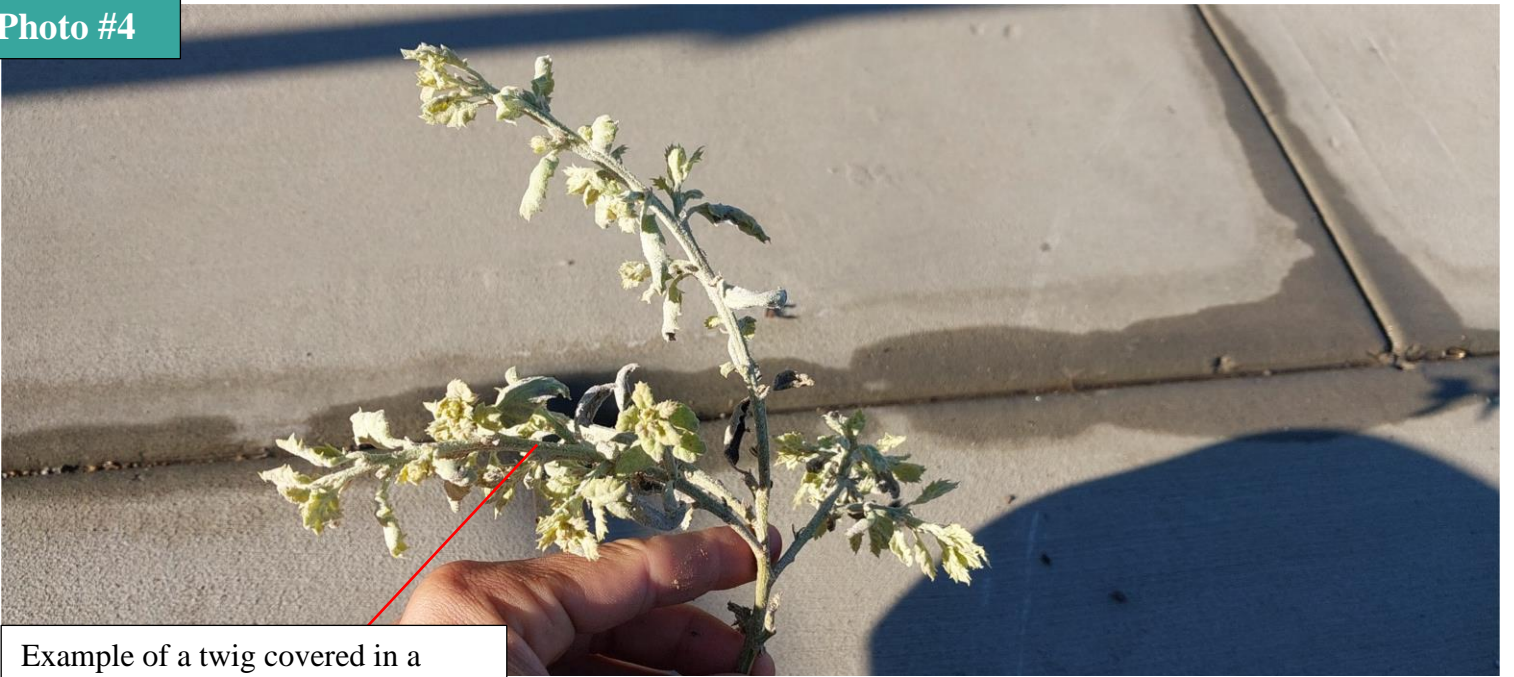
Photo #4

Health - Based on the color and density of the foliage, the tree appeared to be in overall poor declining health². There was severe branch dieback, and overall foliar density was relatively low. Most remaining foliage was infested with woolly aphid pests and the fungal pathogen called powdery mildew (likely *Cystotheca spp.*).

Example of a twig covered in a fungal pathogen called powdery mildew (likely *Cystotheca* spp.).

1. Have a licensed applicator spray the trunk of the tree with dinotefuran (insecticide for the aphids) and phosphorus acid (fungicide to help induce systemic stress response). Additionally, I recommend spraying the foliage with an appropriate fungicide (like phosphites, B.T., or thiophanate methyl).
2. Remove landscape ornamental plants from beneath the canopy and adjust irrigation not to keep soils in a wet state. Preferably deep irregular irrigation adjusted for the weather/time of year.
3. Use a supersonic pneumatic digging tool (air spade) to expose and inspect the tree's root flare.
4. Remove the tree if it does not improve within six months.

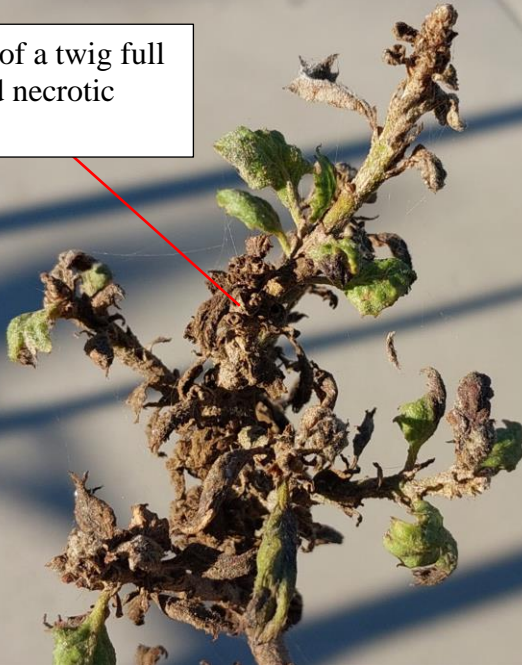
Photo #5

Example of a twig full of stunted necrotic foliage.

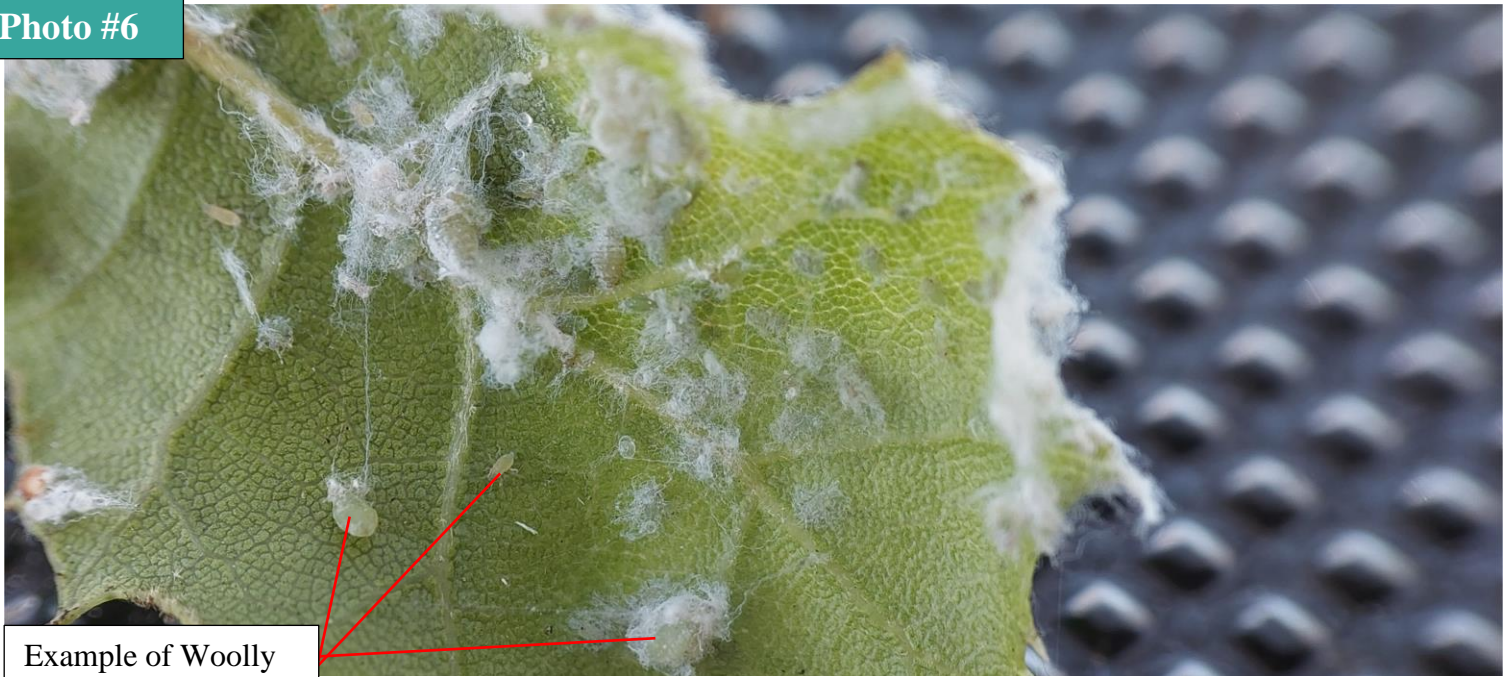
Photo #6

Example of Woolly aphids under a leaf.

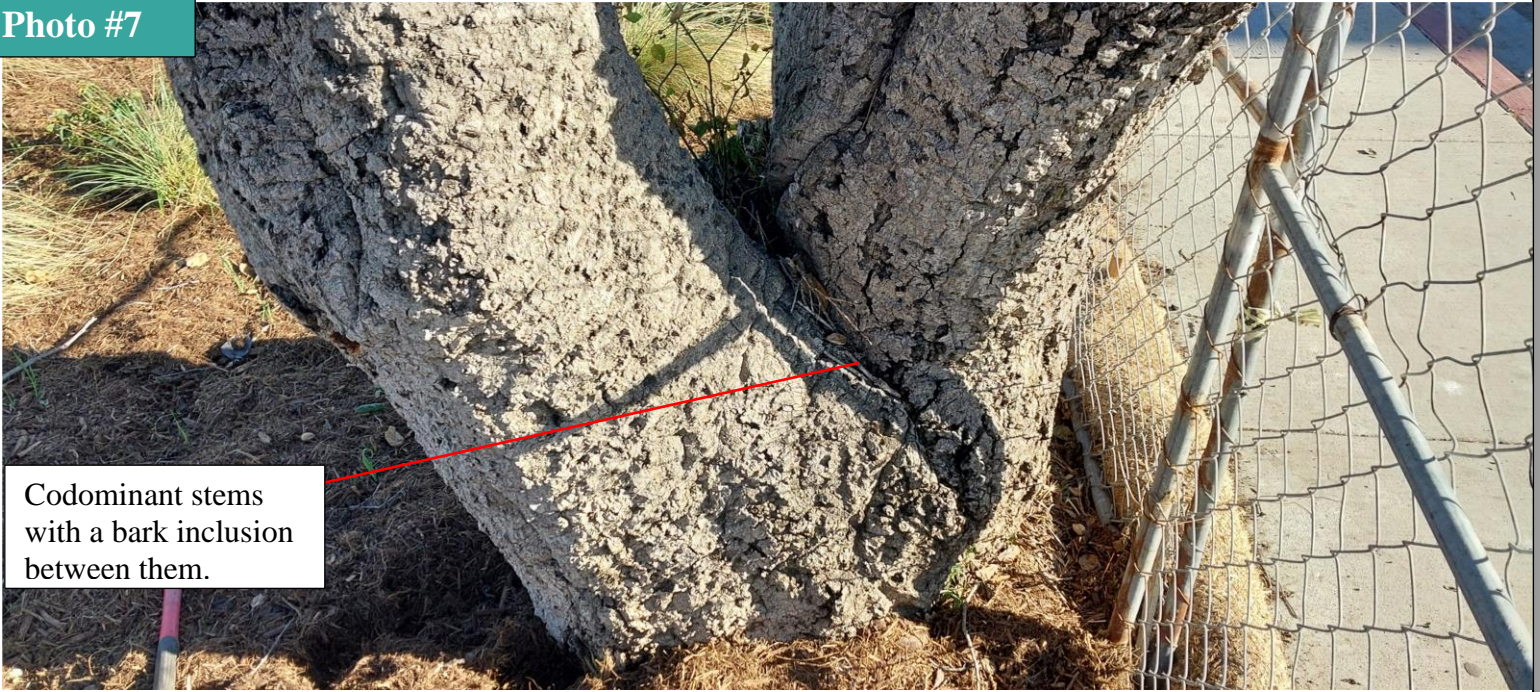
Photo #7

Canopy Structure - The tree's canopy structure was fair to poor; the tree had codominant stems and a pocket of decay in the middle of the tree that was probed to a depth of 14 inches. The branch extending over the road on the east side of the tree had about 14 feet of clearance over the road. Over time, this branch will likely conflict with required fire apparatus clearances.

Codominant stems with a bark inclusion between them.

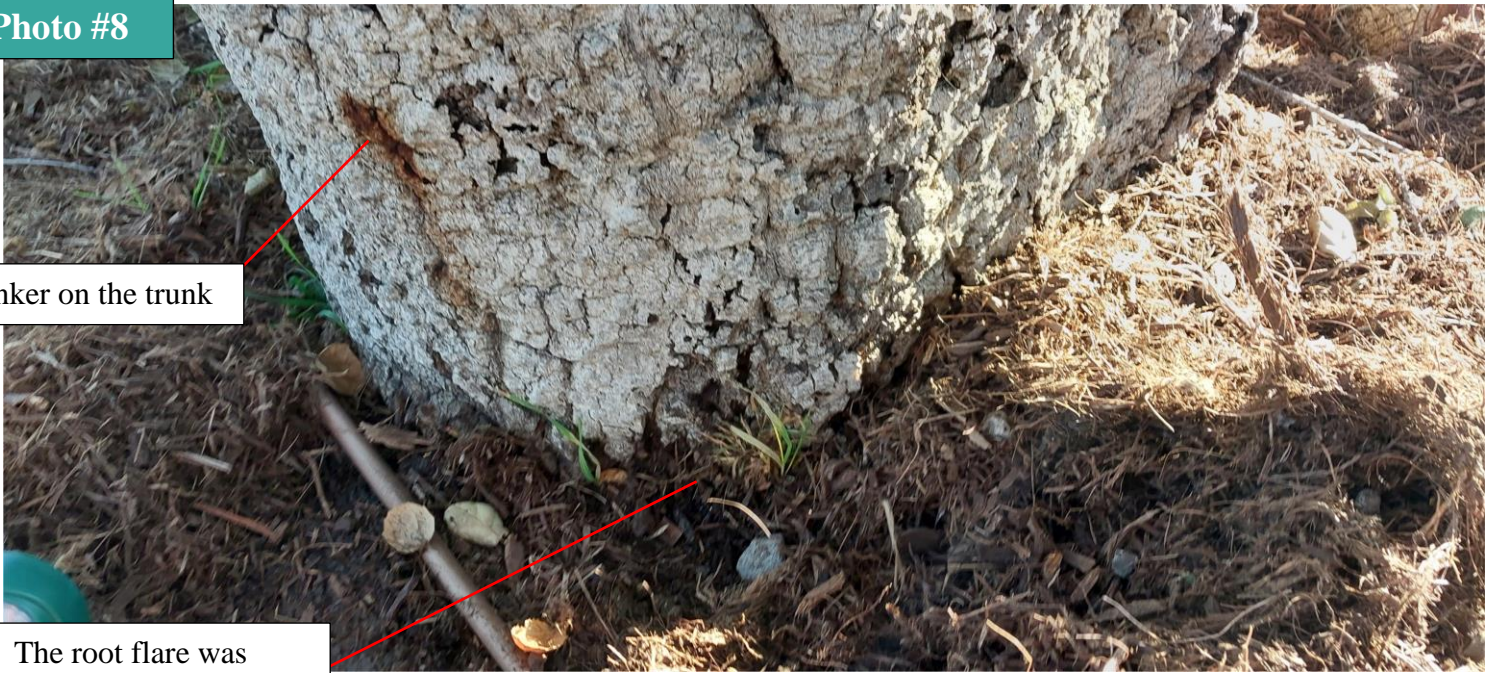
Photo #8

Canker on the trunk

The root flare was buried and mulch was piled up to the trunk.
